# **Corrosion Degradation of Coated Aluminum Alloy Systems through Galvanic Interactions**

**ONR Grant # N00014-13-1-0738**

**PI: Gerald S. Frankel, (614) 688-4128, frankel.10@osu.edu  
The Ohio State University**

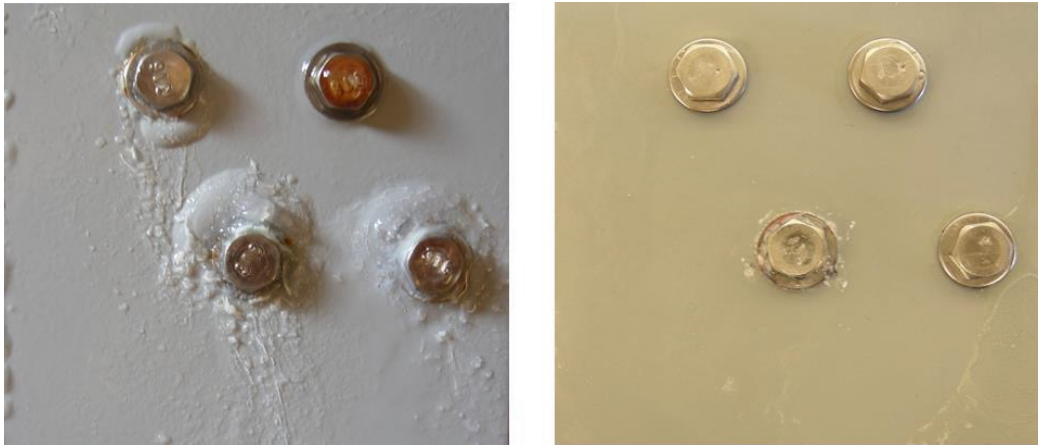
**Figure 3:** Photographs of non-chromated (left) and chromated (right) after 3 weeks exposure to salt spray fog.

In addition to galvanic current data obtained during exposure, OP was used to quantify the amount of material corroded and to gain insight on the attack morphology of each coating system. Figure 3 shows samples after exposure in B117 before removal of the coating. Large blisters formed around most fasteners in the sample with the non-chromated coating system. Interestingly, the one fastener that had no nearby blisters was heavily corroded itself as indicated by the orange coloration. This indicates that it was not interacting with the Al panel and received no galvanic protection. The other fasteners remained shiny.

In contrast to the non-chromated sample, the sample with the chromated coating system had no large blisters and appeared to be relatively unaffected. On the other hand, the measured galvanic current data in Figure 2 indicates that, even though the amount of current passed was less for the chromated coating system, it was still substantial in magnitude.

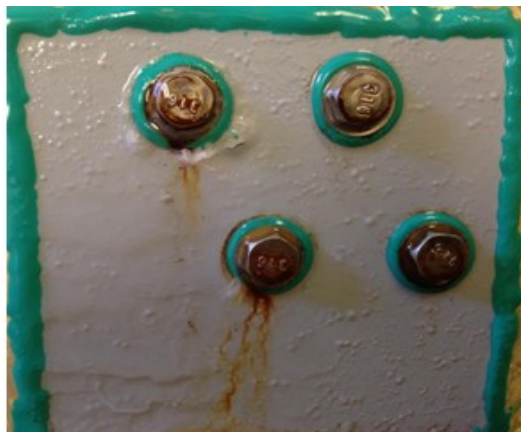
**Figure 12:** Image of galvanic panel with protected fastener holes after 180 days exposure to salt spray conditions.

The condition of the panel after exposure, as shown in Figure 12, is also of interest. Attack is only evident at one fastener site, and the attack is relatively confined. Recall the as-received, unscribed,

non-chromate coating without extra protection in the fastener hole area exhibited massive blisters surrounding most or all of the fasteners.

In addition, all of the fasteners themselves have experienced self-corrosion. The significance of this is that the stainless steel fasteners, which are noble to the panel, should be protected by galvanic coupling if such an interaction is taking place. The attack of the fasteners is indicative of the lack of current flowing from fastener to panel due to the additional protection afforded to potential initiation sites within the hole.

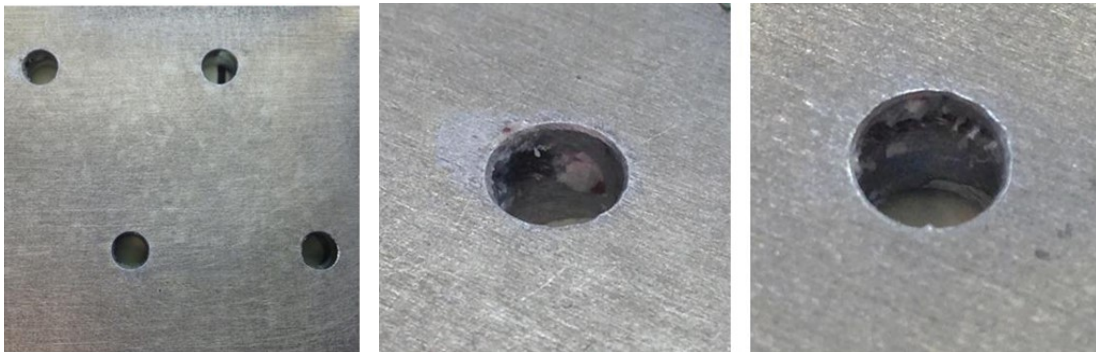
**Figure 15:** Images of sample with as-received hole condition after impressed current testing, showing damage induced to fastener hole wall during impressed current and no attack on top surface (left).

For the protected hole condition, the circuit was not completed, resulting in a measured potential of many volts, essentially reaching the compliance of the potentiostat. Furthermore, the measured current was extremely low, on the order of 0.02 mA, even though the potentiostat tried to apply 10 mA. Finally, no attack was observed on the sample at the end of the test after the coating was removed. In the case of the as-received hole, a reasonable potential of about -0.4 V SCE was measured that was indicative of active aluminum dissolution. The measured current was equal to the applied current of 10 mA for the duration of the exposure, and significant attack occurred to the hole wall, Figure 15.

No attack was observed on the top of the panel for either condition, but a large volume of material was removed in localized areas within the hole for the as-received hole condition, likely corresponding to areas of poor coating coverage. This technique was also attempted in salt spray conditions. For this experiment, fasteners were used and served as the counter electrodes through which current was passed from the potentiostat. The holes were in the as received condition. A period of 24 hours of exposure was used prior to starting the impressed current to allow water uptake into the coating and the formation of an electrolyte layer on the surface. Results are shown in Figures 16 and 17.
